PARABRISAS CITSA DE MEXICO S.A. DE C.V. TEST REPORT

ANSI Z26.1-1996, AS-2 testing on Pruebas de probetas No. 02 de material color filtrasol de espesor 4 mm

103636861GRR-001c

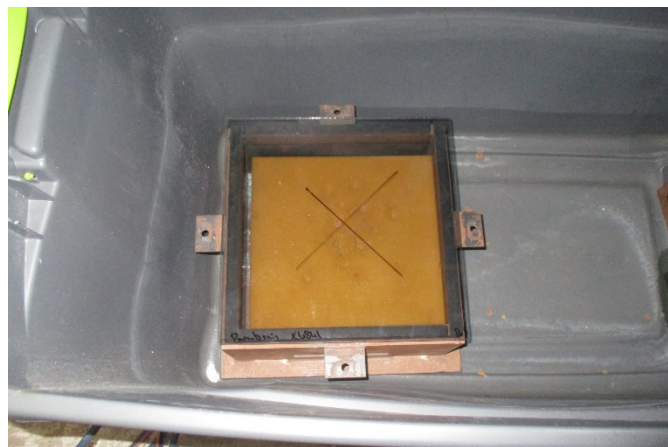
Figure 1: 5.6 Impact, Ball, 3.05m (10ft) Before Impact, Sample 1

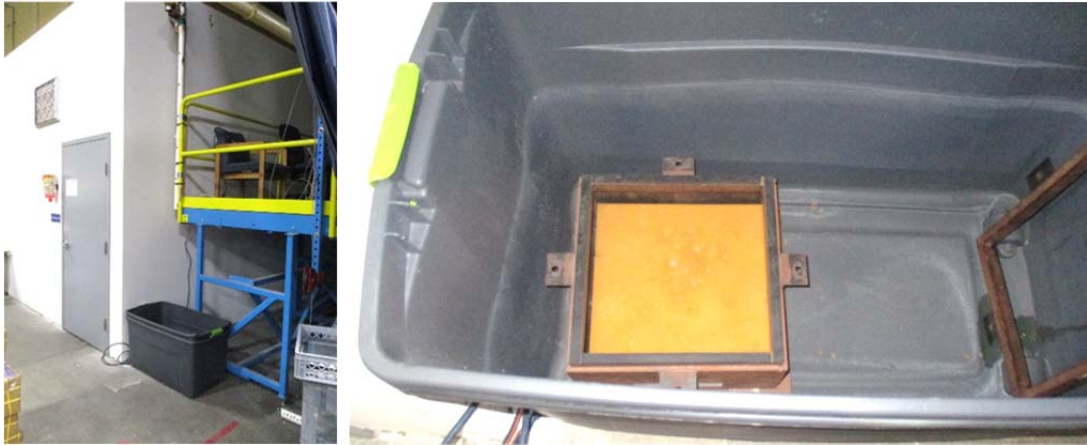
Figure 2: 5.6 Impact, Ball, 3.05m (10ft) Set-up

Test Method: Per ANSI Z26.1-1996, AS-2 section 5.6
Condition: At least 4 hour 21°C to 29°C (70°F to 85°F) immediately
was preceding the test.
Fixture: Steel frame
Impactor: 225 g (224 to 230) g (0.5 pound ± 0.1 oz) smooth, steel
sphere.
Height: 3.05 m (10 feet), once, freely and from rest, strike 25 mm
(1 inch) from center.
Side: Exterior side: Either side per client's email dated
09/05/18
Number of Samples: 12 of 305 mm x 305 mm (12 in x 12 in)

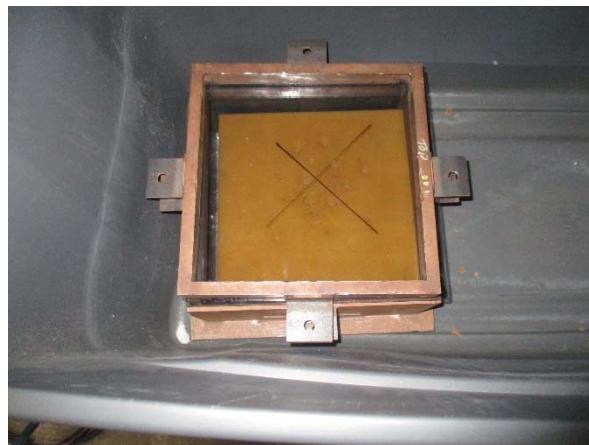
Figure 3: 5.6 Impact, Ball, 3.05m (10ft) After Impact, Sample 1, No Break

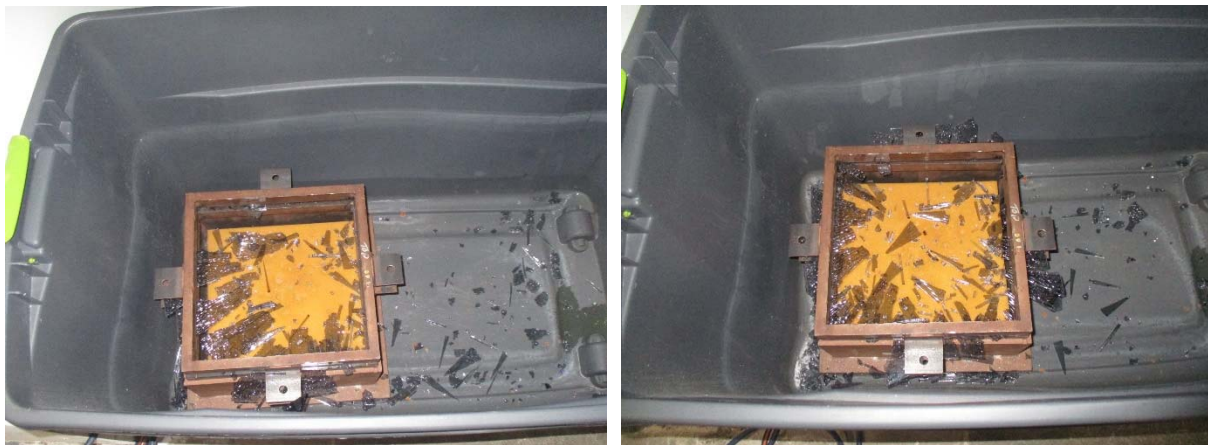
Sample 4

Sample 6

Figure 4: 5.6 Impact, Ball, 3.05m (10ft) After Impact, Sample 4 and 6, Breaks

SPECIMEN	CRACK OR BREAK	IF BREAK, FRAGMENT FREE OF CRACK OR WEIGH MORE THAN 4.25 G	DISPOSITION
1	None	---	---
2	None	---	---
3	None	---	---
4	Break	0.51	---
5	None	---	---
6	Break	0.55	---
7	None	---	---
8	None	---	---
9	None	---	---
10	None	---	---
11	None	---	---
12	None	---	---
More than two specimens crack or break: No			Conforming
